JAN 2023

# Technical Newsletter

## x86&Novatek chipset NVR main board replacement

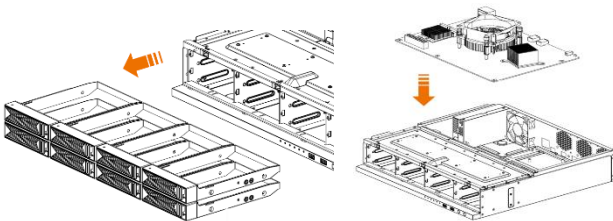
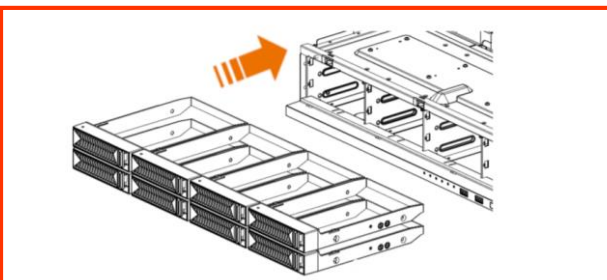
### 3. Application : Detach all existing HDDs before replacing to new mainboard

**[Notice]** Errors including FTP fail, e-mail sending fail and cemrea registration fail may occur if HDD is not detached prior to repair

Detach existing HDD

New board replacement  
& booting

Installation wizard :  
IP&PW setting

CS Tool :  
Insert MAC, S/N info.

After rebooting :  
Power-off/ HDD attach

Information synchronized  
& repair completion
