Technical Newsletter

SSM Ver. 2.13.01 Update

Technical Newsletter June 2023

SSM settings for automatic backup and recovery

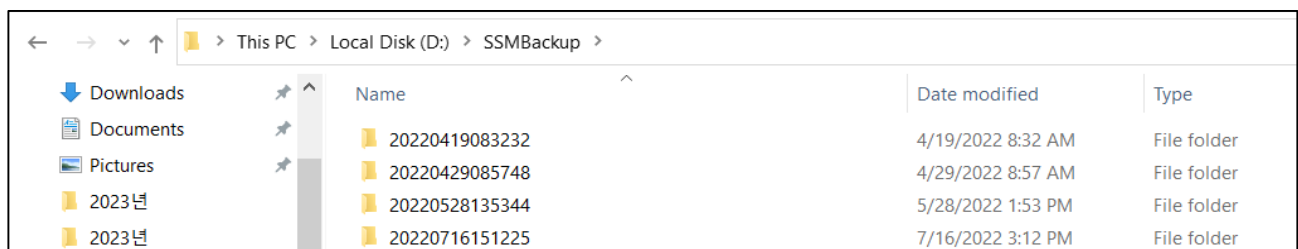
- Create in the SSMBackup folder for the first drive to be found except C drive
- Generated in the form of YYYYMMDDHHMMSS (date, time, and minutes) of the backup
